Loe Pool SSSI Macrophyte Monitoring 2014

Quantitative survey of four permanent transects

Report Date: November 2014
Author: Dr Jan Dinsdale
Survey Dates: 12 & 15 September 2014
Dive contractor: Kennack Diving
Ecologist: Dr Jan Dinsdale

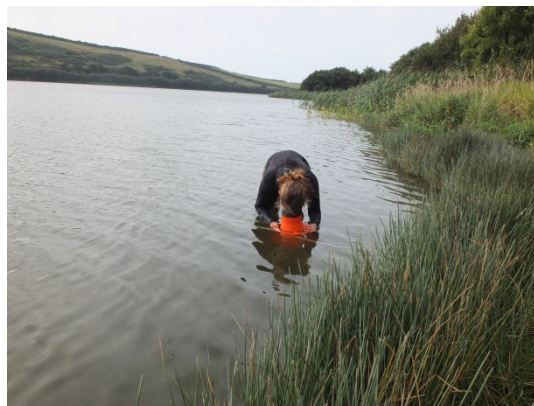
Photo 3: Surveying with bathyscope. Wearing a dry suit was very useful when surveying the deep end of the transects (Jan Dinsdale)

The 2012 survey found that, using the bathyscope, it was difficult to accurately record plant abundance in water depths in excess of 1m due to poor visibility and poor light penetration. In 2014, we trialled the use of scuba-diving to assess plant abundance in deeper water. Diving was only employed for Transect 3, Pentire Point. Bathyscope observations were sufficient to see the full extent of the plant communities along the other three transects.

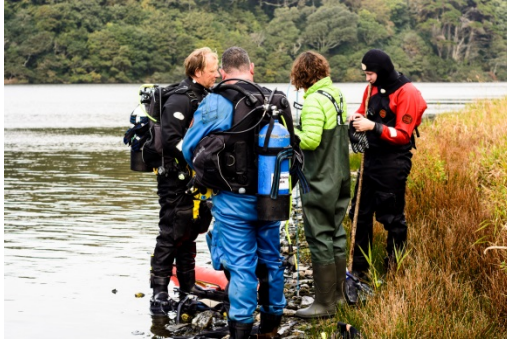
Photo 4: Kennack Divers preparing to enter Loe Pool from the shore to commence the Pentire Point dive (Adrian Eggett)

A team of three qualified scuba-diving staff (David Roberts, Des Glover and Chris Cattlin) surveyed the quadrats along Transect 3 that were located at water depths beyond 1m depth. Plant identification assistance was provided by the project ecologist, who remained on the shore. The diver's entry into the lake was from the shore (Photo 4). Divers worked in buddy

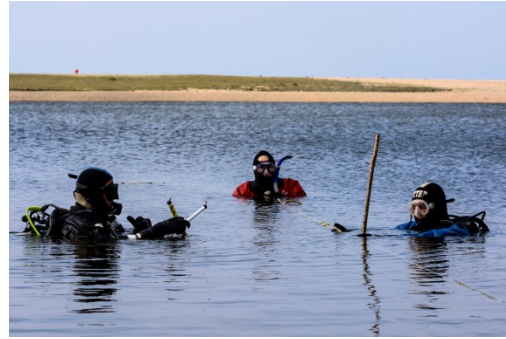
Photo 5: Divers surface from undertaking the transect survey at Pentire Point (Adrian Eggett)

pairs at all times to comply with The Diving at Works Regulations 1997 (HSE 1997) and a third team member floated on the surface (Photo 5). A Diving Risk Assessment was produced prior to the dive operations in accordance with the Scientific and Archaeological Approved Code of Practice (HSE, 1998) (*Appendix 2*).

Visibility was extremely poor during the 2014 survey, less than 0.5m. Divers needed to be within 0.3m of the lake floor, in order to carry out a thorough search for macrophytes rooted within the quadrat. Any contact with the lake's unstable benthic sediments rapidly reduced visibility to 0.0m. The need for accurate and careful movement underwater combined with poor visibility made the scuba-divers progress very slow at times, and inevitably resulted in significant disturbance of the benthic sediments.

In view of current water clarity in the Loe, a bathyscope provides a reliable method for surveying this community type up to a maximum depth of 1.0m. Scuba-diving is not currently required or recommend as part of the bi-annual permanent transect survey, as with such reduced visibility we found that the divers impose an unacceptable level of physical disturbance on both the vegetation and the benthic sediments along the route of the permanent transects.

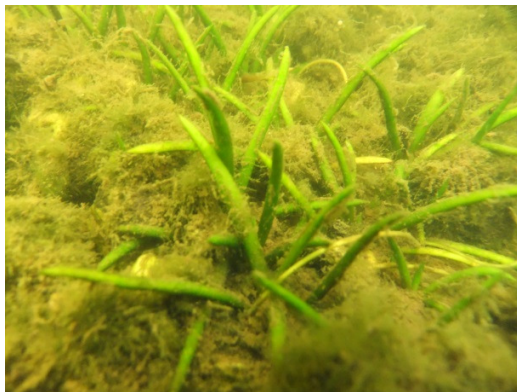
Photo 6: Shoreweed (*Littorella uniflora*) at 0.2m water depth on stony substrate clothed in algae (Des Glover)

Cladophora type algae was abundant across all four transects on both sandy and stony substrates (Photos 6 and 7).

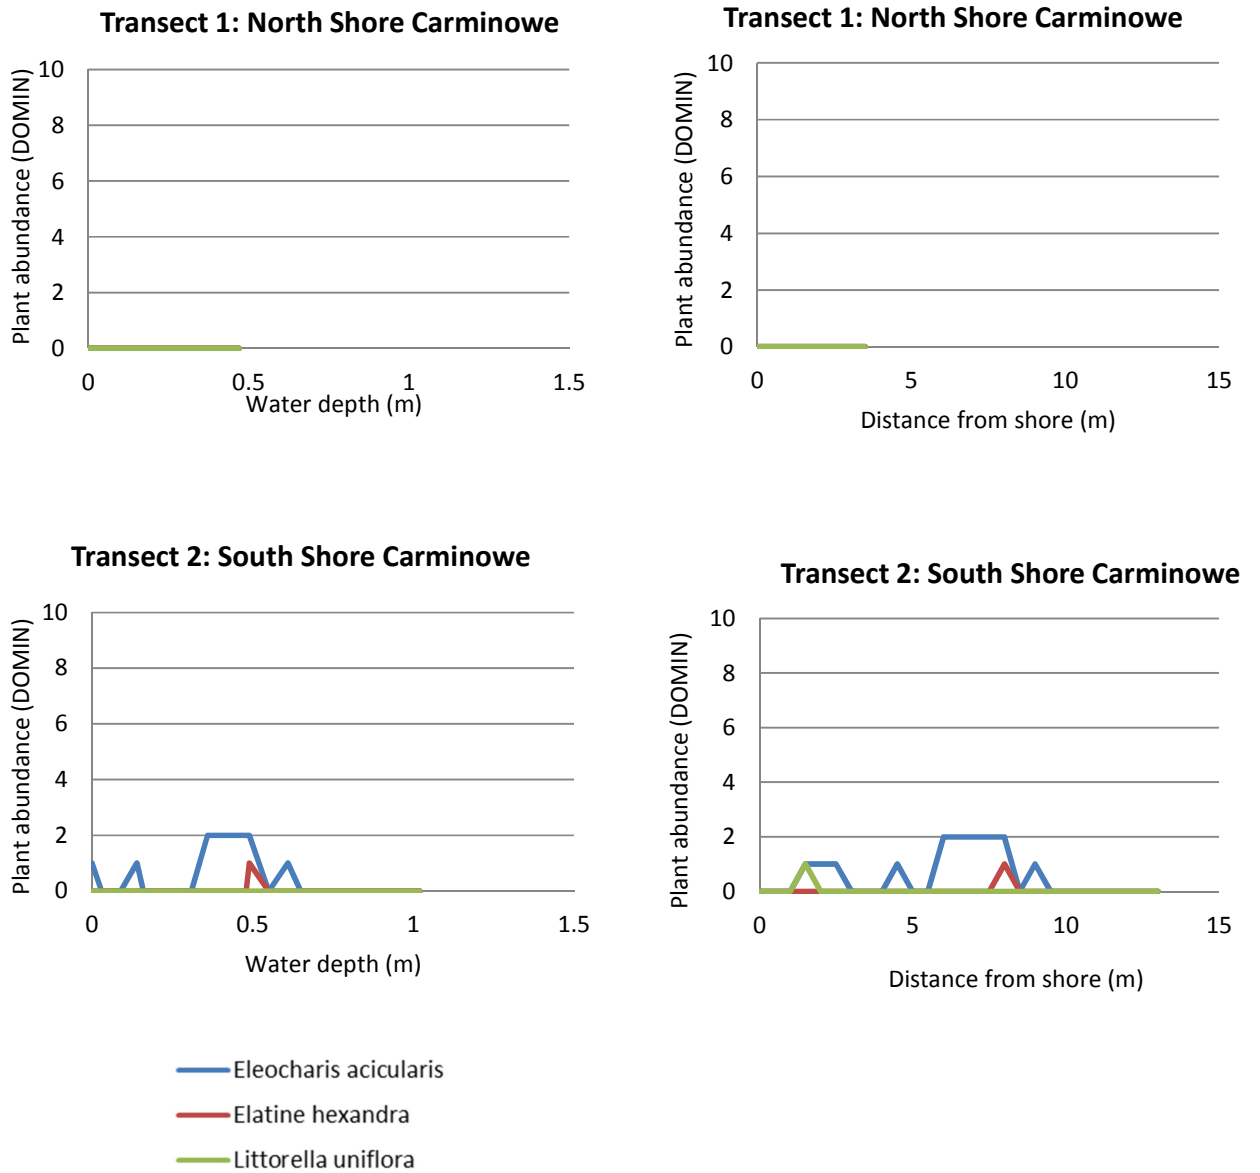
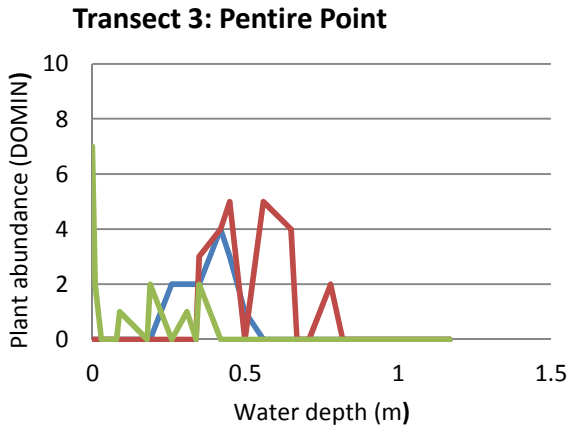
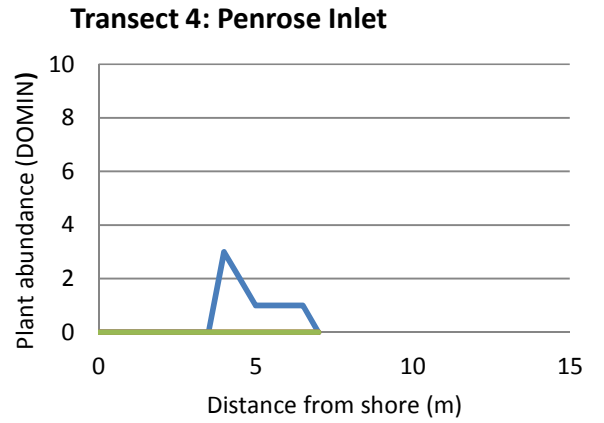
Figure 2: Variation of species abundance within the inundation community with water depth and distance from shore along four transects within Loe Pool SSSI, September 2014

The 2014 quantitative survey results of the four permanent transects are shown in Figure 2 below and, for comparison, the 2012 results follow in Figure 3.

All three aquatic plant species recorded in 2012, Shoreweed, Needle Spike Rush and Six-stamened Waterwort were present in the quadrats in 2014. These three species frequently occurred together in Loe Pool on sandy and stony substrates in shallow water depths, up to 0.7m. They did not extend into deeper water or onto the mobile silts. Shoreweed alone was also recorded in areas of larger cobbles.

In many areas of the lake shore a community zonation is present, with Shoreweed more frequent in the shallows to a depth of 0.3m and Six-stamened Waterwort found in deeper water, 0.5m-0.6m. Needle Spike Rush, occurs across the full range of both other species.

The abundance of Shoreweed, Needle Spike Rush and Six-stamened Waterwort declined across all four transects in 2014 when compared to 2012. All three species were lost from Transect 1 and the abundance of each of the three species declined in Transect 2. Transect 3 exhibited the most stability in the plant community between 2012 and 2014; retaining all 3 species with an increase in the abundance of Shoreweed and a corresponding decrease in Needle Spike Rush in the lake's seasonally dry drawdown zone. Shoreweed was absent from Transect 4 in both 2012 and 2014; the abundance of both Needle Spike Rush and Six-stamened Waterwort declined between 2012 and 2014 along this transect

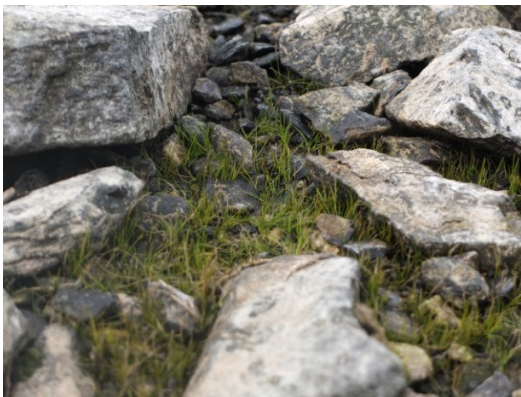
Photo 8: Needle spike rush (*Eleocharis acicularis*) in the drawdown zone, September 2014
(Jan Dinsdale)

Historic shoreline flora data strongly indicate the presence of a summer drawdown zone at Loe Pool (Stewart, 2000). An increased summer drawdown zone would improve both the extent and quality of habitat for the inundation plant community: Six-stamened Waterwort, for example, does not flower beneath the water (Stace, 1997); Shoreweed can tolerate extreme inter-annual fluctuations in water levels and long periods of exposure (Natural England, 2010). Generative reproduction occurs during dry periods, on the emerging sediments or in extremely shallow water (Brouwer *et al.*, 2002). Additionally, periodic emergence of the sediment of shallow lakes stimulates germination from the seed bank (Brouwer *et al.*, 1999). Most softwater macrophytes produce long-lived seeds and re-establishment from the seed bank often occurs in large amounts (Bellemakers *et al.*, 1996).

Based on these predictions, it is recommended that a seasonally varying water level management is adopted, with winter lake levels maintained higher than summer levels. Using bathymetric data collected by Mason Survey in 2000, Haycock (2000) calculated that a fixed water level at 3.5m AOD constant year round delivered a normal range of approximately 3.5 to 4.1 m AOD and exposed a 7.6 ha of littoral edge during dry periods. These calculations can be extrapolated to predict that a new water level management regime of winter 3.5m AOD and summer 3.05m AOD would increase the littoral shore by up to 3.5 ha, giving a total littoral area of 11.1 ha. This extended drawdown zone could be delivered with the current outlet structure at Loe Bar and would benefit both the plant and the macro-invertebrate communities and also be consistent with Natural England's Conservation Objectives for the site (Natural England, 2010).
